Figure 5-5: Greenbelt Soils

5.1.1.2 Soils

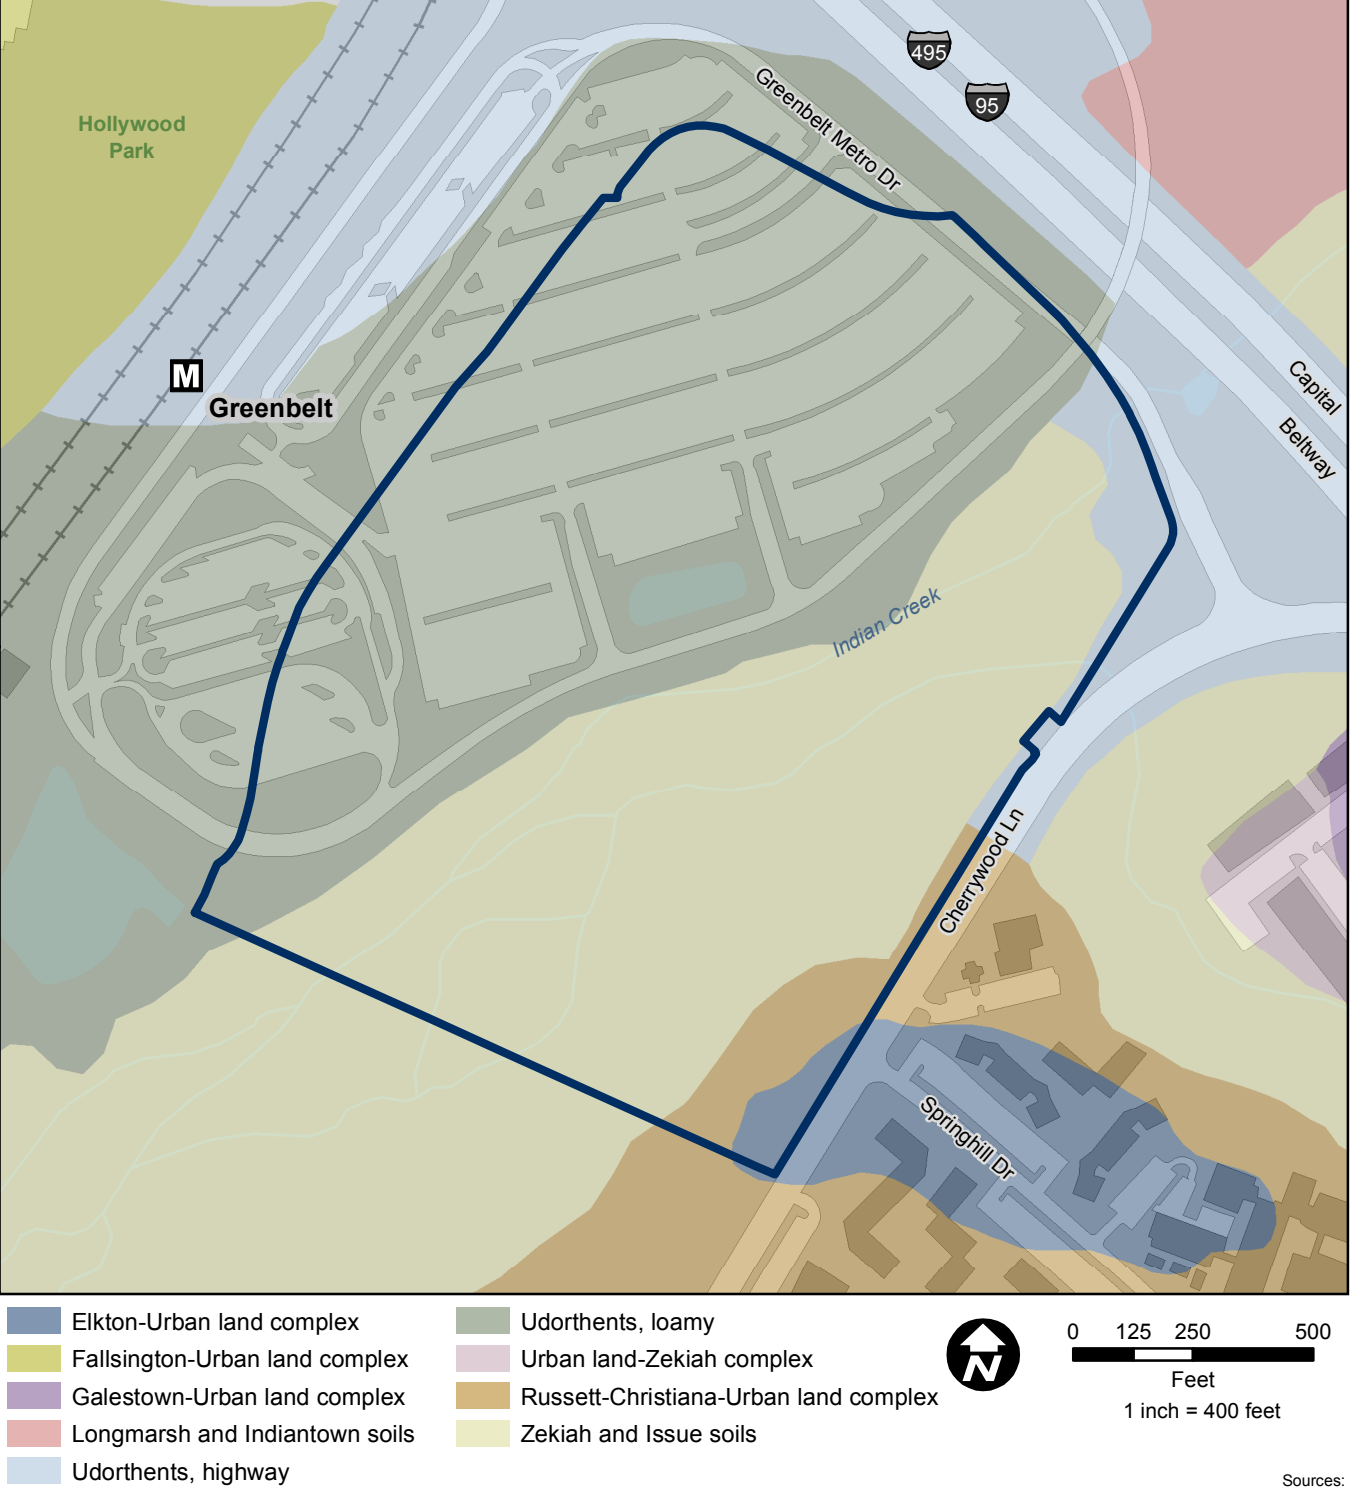
The majority of the site northwest of Indian Creek is paved asphalt, while the southeastern half of the site is forested. Fill material from the construction of Lake Artemesia has been placed at the site for development of the surface parking lot. The United States Department of Agriculture (USDA) Natural Resource Conservation Service (NRCS) has identified five major soil associations within the Greenbelt site, as shown in figure 5-5 and table 5-1. None of the soils identified at the site are considered highly erodible soils, nor are any of the soils considered to be prime farmland (Prince George's Soils Conservation District 2013). Soil associations and their characteristics are listed from east to west in table 5-1.

There are two Udorthent associations located on the Greenbelt site. The Udorthent, highway association soils, are located mainly along the western and northeastern site boundary and comprise approximately 14 percent of the site, while Udorthent, loamy association soils, are located primarily throughout the center of the site and along the southwestern and northern boundaries and comprise approximately 57 percent of the site. It is important to note that the buildable area for this site alternative is located exclusively within these two Udorthent associations.

The Udorthent, Highway association soils map unit is primarily composed of human transported material/urban land and has a wide range of slopes varying from 0 to 65 percent, with slopes within the site towards the lower bounds of this range. The Udorthent, loamy association soils, have a much more gradual slope, of 0 to 5 percent and are composed primarily of loamy deposits.

This soil complex is located within the eastern center and along the southern boundary, and comprises approximately 26 percent of the site. Zekiah and Issue soils consist primarily of loamy alluvium and are typically located along floodplains and drainage ways. Slopes generally range from 0 to 2 percent. This soil association is deep, poorly drained, and has a high frequency of flooding (i.e., a greater than 50 percent chance of flooding in any given year during normal weather conditions). These soils have very limited building potential as a result of their frequent flooding. The K factor of these soils is 0.37, with a wind erosion rating of 5.

This soil complex is located in the southeastern portion of the site, and together with the Elkton-Urbana complex comprises the remaining 3 percent of the site.

The Russet-Christiana-Urban land complex is located in the southeast portion of the site and consists primarily of clay deposits with slopes ranging from 0 to 5 percent. This soil association is deep, moderately well drained, and has nearly a 0 percent chance of flooding, similar to the Udorthents. These soils have somewhat limited building potential as a result of their depth to the saturated zone. The K factor of these soils is 0.49 with a wind erosion rating of 3. These soils meet the criteria for hydric soils, which indicates past or present wetlands.

This soil complex is located in the southeastern portion of the site, and as noted previously, together with the Russet-Christiana-Urban land complex comprises 3 percent of the site.
